SCOPE OF WORK FOR THE STABILIZATION AND PRESERVATION OF THE LEIGH LAKE PATROL CABIN 2008

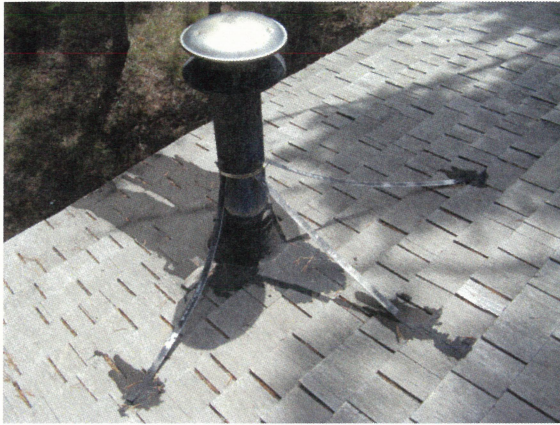
Roof Stove Jack

The roof section of the project, besides new fire resistant shingles, will also include replacement or partial replacement of any 1"x 10" roof sheathing boards, replacement of the 1"x 4" roof board end supports, removal and replacement of the roof stove jack and removal and replacement of the 1" x 6" roof ridge boards.

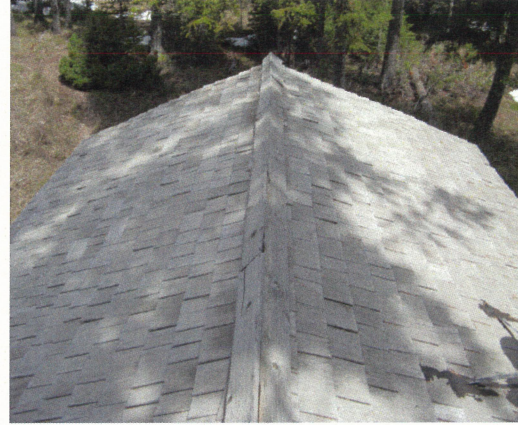
Roof Ridge Boards

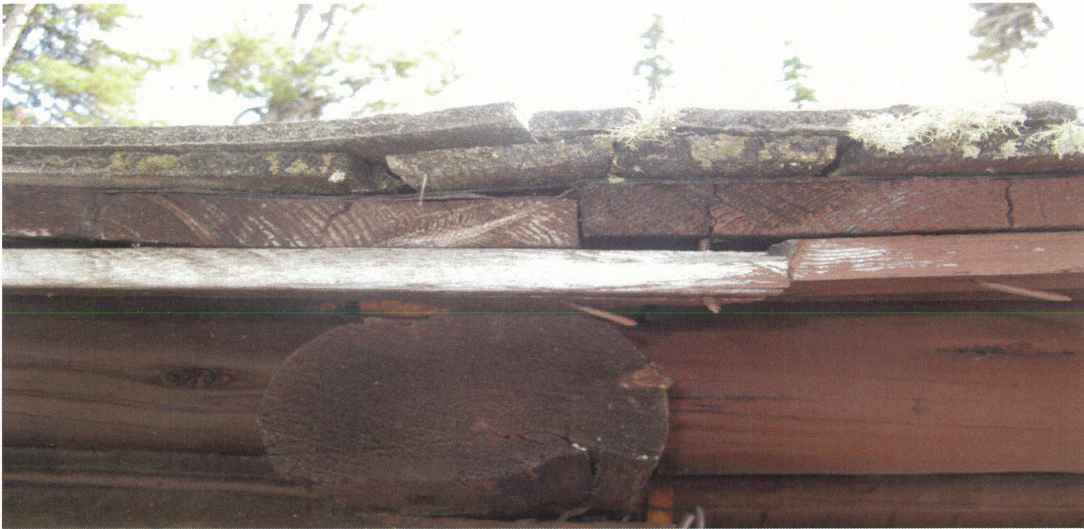
Top to Bottom: shingles, sheathing boards, sheathing board end supports

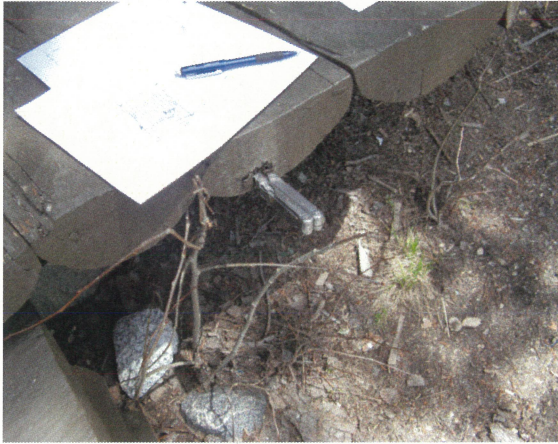
The porch deck is made of half logs. The deck is V shaped from the center back to each porch sidewall. From the center or longest half log on the left side (South view) the first three deck logs are end rotted to the point of replacement or partial replacement. The replacements will be obtained locally from area timber downfall. Approximately three feet back beneath the deck is a support log extending from one side of the deck to the other side of the deck. The deck support log is braced in the center by a section of 10" log from the ground surface to the bottom edge of the log. This support brace is rotten and will also be replaced.

End Rot on Half Log Deck

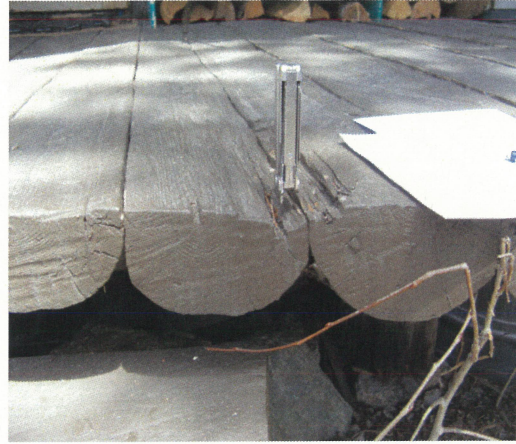
End Rot on Half Log Deck

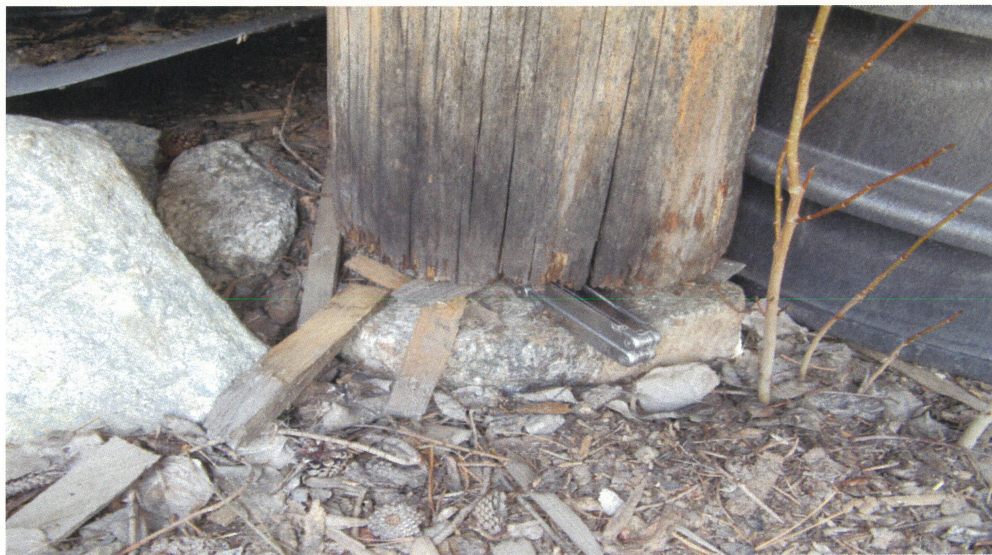
Rotted Brace for Front Deck Support Log

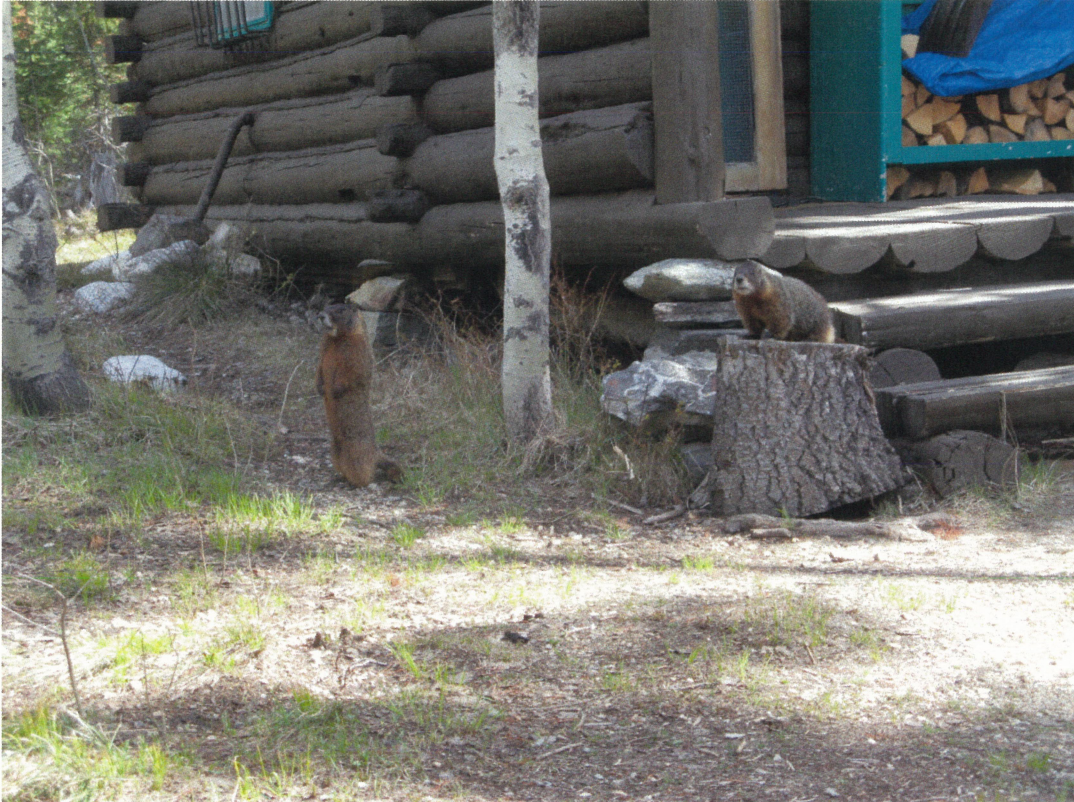
The second log above the deck surface on the East porch sidewall has an area of decay that needs to be removed and repaired. The decayed area is not large enough to require a Dutchman repair or replacement. The decay will be removed and an epoxy repair will be done.

Epoxy Repair Located 2nd Log above Deck Surface Extends From Log End to Behind Aspen Tree

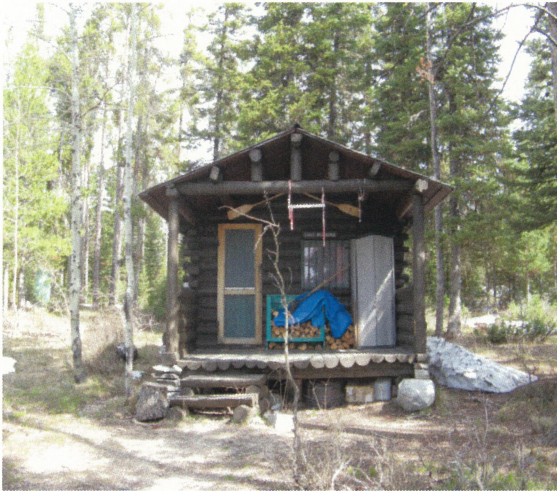
Front Window South Elevation View

The windows at the Leigh Lake Cabin are double hung style laid on their sides and used as sliders which is prevalent throughout Grand Teton National Park on the historic cabins. The three windows, including frames, sashes and trim, on this cabin are in need of repair and painting. This will require their removal, covering the opening and their replacement.

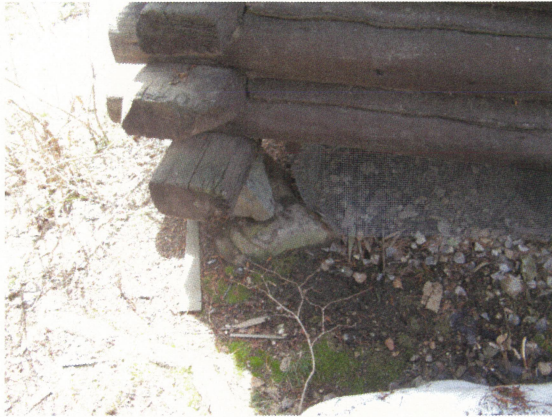
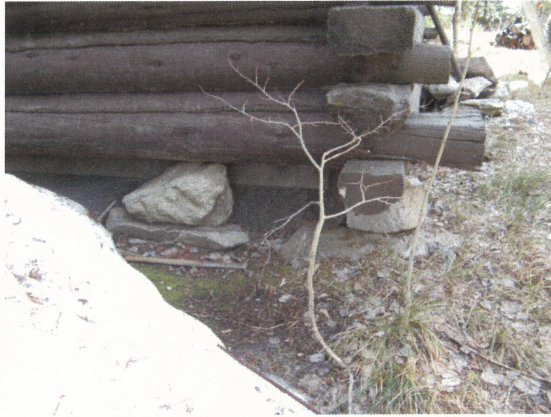
A few of the cabin log ends, although not in need of replacement, would benefit from wood stabilization. The ends will have the paint removed, consolidated and epoxy repaired if necessary.

Square Notched Log Ends
